PANTOGRAPH CONDITION MONITORING SYSTEM FOR AUTOMATED MAINTENANCE INSPECTIONS AND PREVENTION OF OVERHEAD WIRING TEAR DOWNS

Shane Doyle¹, Codruta Bastucescu¹, Tim Vale²

¹Engineering & Maintenance Directorate, Sydney Trains, NSW, AUSTRALIA

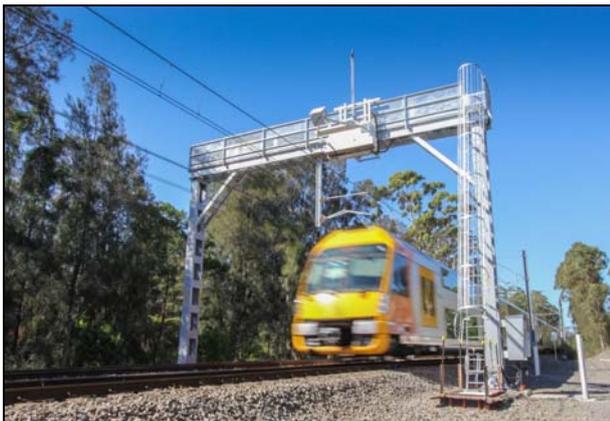
Figure 1: Thornleigh trial PCMS

The trial phase of this project comprised a business case for a trial PCMS, the procurement of the trial PantoInspect system following an open international tender, the design and construction of the civil, electrical, communication and signalling infrastructure at one site (Thornleigh) and a six month technical trial.

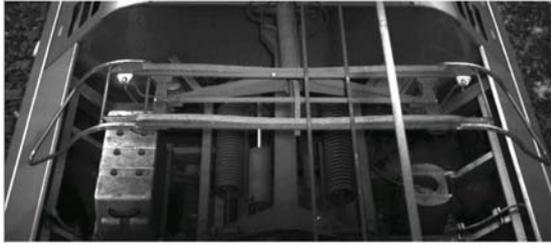
Figure 4: Operator viewable photograph of the pantograph

alarm of appropriate severity to the operator. A photograph of the pantograph allows the operator to confirm the issue prior to taking action.

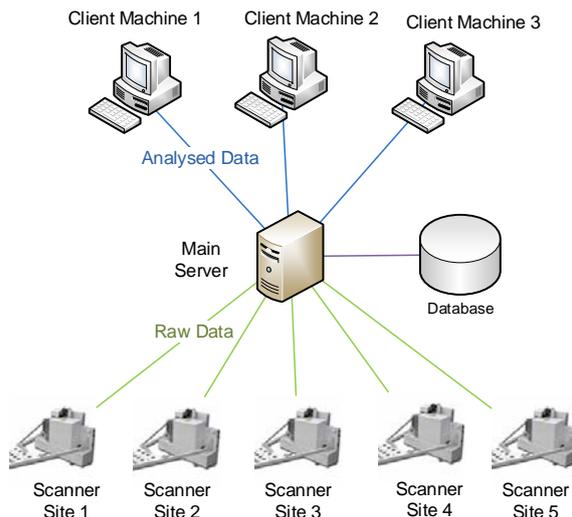
Figure 5: PCMS architecture

The PCMS consists of multiple monitoring sites that collect data and feed it back to a centralised server for processing. The result of the analysis is then presented to the user's client machines. All pantograph data is stored in a database for future reference.

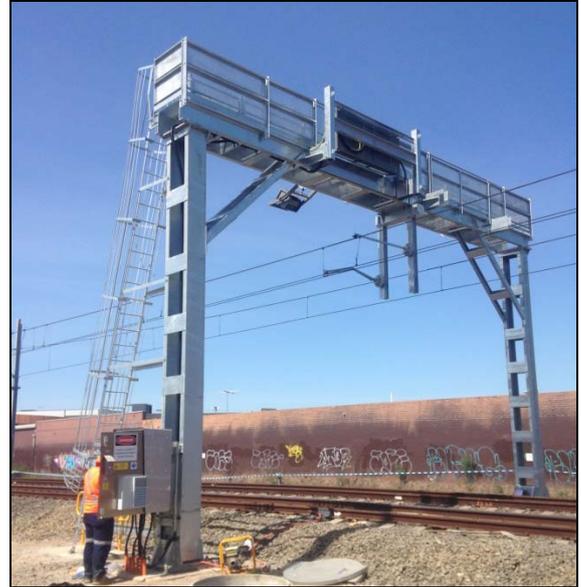
Figure 6: PCMS monitoring site

As a train enters a monitoring site, a track mounted wheel detector alerts the system of the incoming train. This activates Radio Frequency Identification (RFID) Tag Readers which are used to detect every vehicle ID. The vehicle IDs are then cross checked against a vehicle database to determine the train type and the corresponding pantograph types for data analysis purposes, and the Train ID (also referred to as a set number). The train then passes under the PCMS scanner where the pantograph data is captured. A second wheel detector underneath the scanner is used as a safety system to ensure that there is a train directly below the scanner prior to firing the lasers.

The monitoring site's power and data connection is made at the wayside cabinet mounted to the mast of the gantry. This controls the distribution of power and communications for the equipment throughout the site.

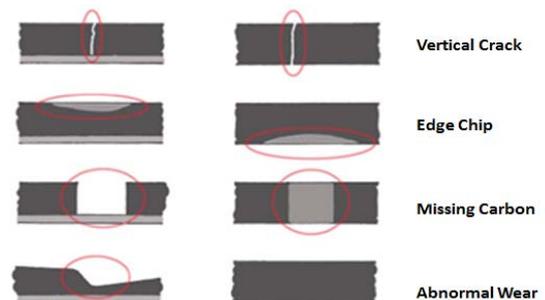
Figure 7: Carbon defect types

- Minimum carbon thickness of each carbon strip at any location along the wear region. The thickness is calculated relative to non-wear reference points on the laser line and a defined relative zero location.
- Carbon strip defects or irregularities (unlimited in quantity) such as missing carbon; edge chips; abnormal wear and vertical cracks.

The distinct shape of the three laser lines defines the defect type. Figure 7 depicts these shapes.

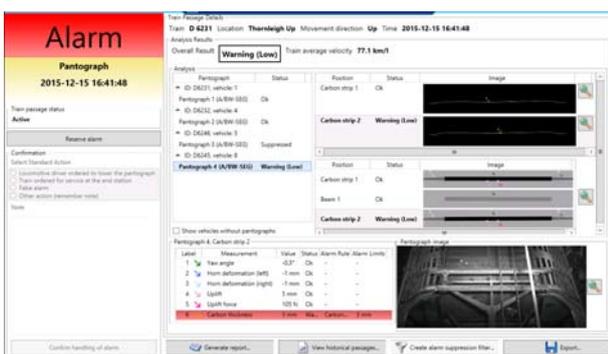
Figure 8: Pop-up alarm generated by PantoClient software

When the PCMS detects a defective pantograph head, a pop-up window is generated in the client software that shows the details of the alarm.

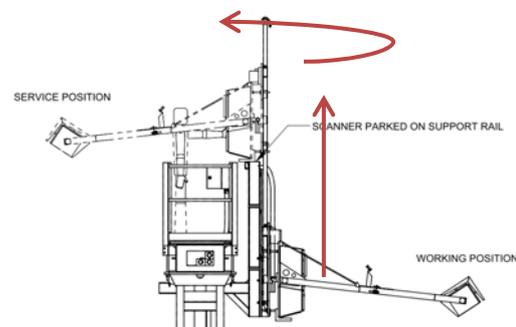
Figure 9: Original mounting of PCMS to gantry

The first monitoring site was installed as a part of a trial of the PCMS for Sydney Trains. The solution developed for this site was an adaptation of the system that was used in other PantolInspect installations where maintenance access was achieved by winching the scanner unit up a pole and turning it 180 degrees. This first system is depicted in Figure 9.

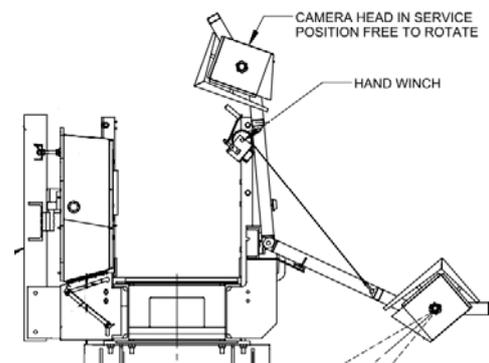
Figure 10: Revised mounting of scanner to gantry

For the roll-out of the PCMS monitoring sites, a new design approach was used that integrated the scanner much more closely with the gantry, allowing for a more convenient mounting arrangement. The redesigned mounting arrangement for the scanner is depicted in Figure 10.

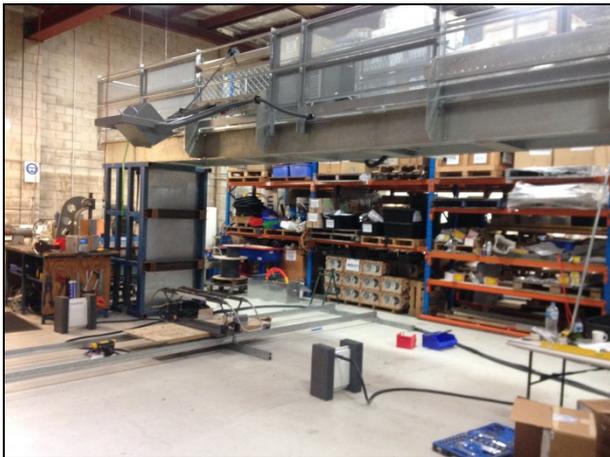
Figure 11: Factory acceptance test set-up.

Factory Acceptance Testing included setting-up the entire system in ART's warehouse and running a wide variety of typical pantograph defect types on a trolley under the scanner.

The Factory Acceptance testing was completed with all pantograph head types of both new and worn condition and with simulated carbon, yaw and horn defects. The simulated carbon defects were machined into both actual carbon strips and replica wooden strips to try and control the defect shapes and dimensions as much as possible. The wooden strips were easier to machine than the actual carbon which meant they were dimensionally very accurate. However the infrared properties of the wooden strips and the resultant intensity of the laser lines were difficult to match to that of real carbon which created issues relating to analysis of the raw laser line and measurement accuracy.

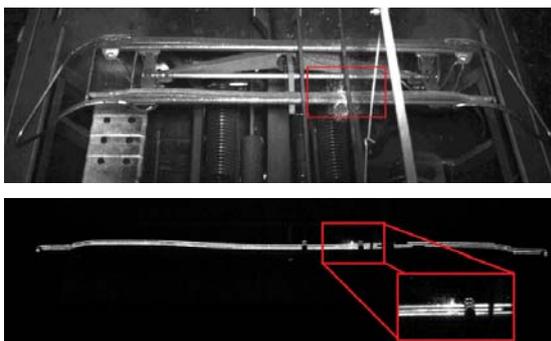
Figure 16: Heavy rain example

- Heavy rain was generating false alarms due to water build up on the contact wire which creates a “splash” effect of the lead carbon strip and impacts the laser images being recorded by PCMS. See Figure 16 for an example. This was resolved by PI improving the filtering of the laser line images.

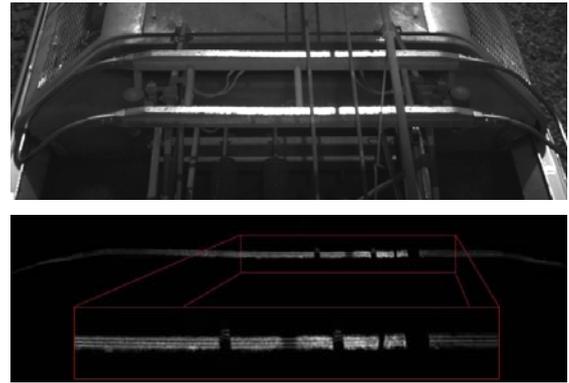
Figure 17: Sun reflection example

- Sun reflections off the carbon strips during certain hours of the day at different times of the year. The effect of the reflected sunlight is a more diffuse laser line profile which increases the risk of PCMS detecting false edges or grooves and thus generating false alarms. See Figure 17 for an example. This was resolved partially by improved image processing filtering but the most reliable and permanent solution was to aim the PCMS cameras in the same direction as the sun to prevent the reflections occurring altogether.

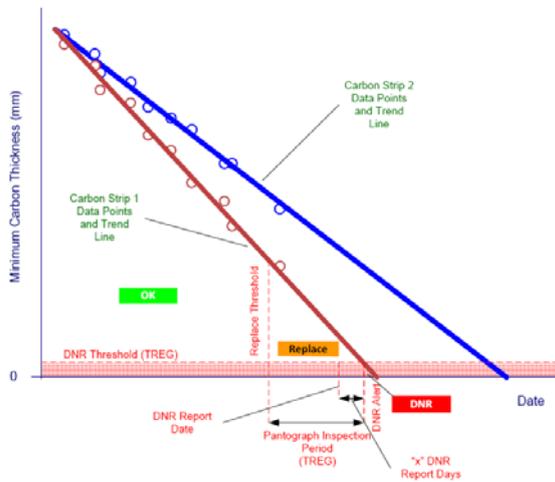
Figure 18: Carbon maintenance statuses

final critical factor is in deciding how these states are determined and applied. The graph shown in Figure 18 details how this is done for carbon thickness.
