Innovative PantoSystem prevents service disruptions by identifying broken spring box in the RER Network of RATP

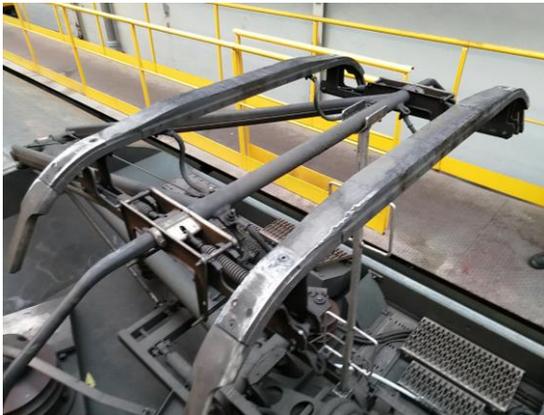
Figure 1: The damaged pantograph

Within a two-week interval, incidents related to the spring box of two separate pantographs running on opposite train tracks, were identified. In one of the incidents, the abnormal wear of the carbon strip kept deteriorating, and when the carbon strip finally had a pitch angle between $-3,8^\circ$ and $-3,4^\circ$, the PantoSystem generated a level 1 alarm in one of RATP's RER networks, indicating a warning of high importance. After examining the 3D images of the pantograph, the PantoInspect team urgently sent an e-mail to warn RATP about the carbon strip, which had clearly been bended. Immediately after, the exploitation team of RATP took the train off the track and when the problem was investigated by the maintenance team, they confirmed that the horn of the pantograph was hit by an unknown object, causing the spring box to twist on one side.

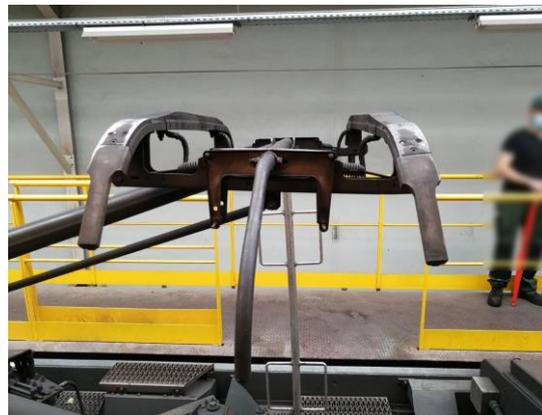
Figure 2: Carbon strip shows clear pitch

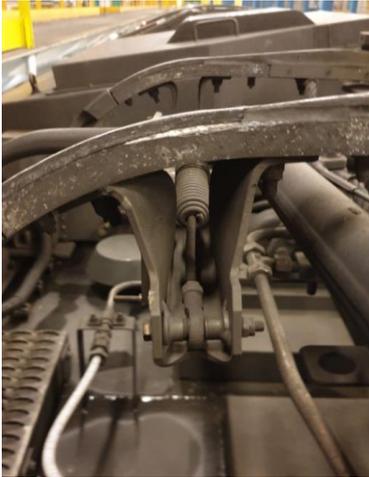
Figure 3: Broken spring box

of the twisted or broken spring box, by accurately measuring the geometry of the pantograph. The automatic system is important due to the fact that RATP has about 90 km of tracks on each direction, a total of 180 km track on both directions, and since this type of problem does not happen frequently, manually identifying this type of defect throughout the RATP fleet would have been very time-consuming and costly for RATP as it is not visible from the ground. Additionally, to manually investigate if more trains were affected would again require a major effort.
